Manhole Inspection Summary

Manhole # S33EE_022MH

Insp Date: **2/21/07 11:38 AM**

Location Address: **1111 CHARLES ST**

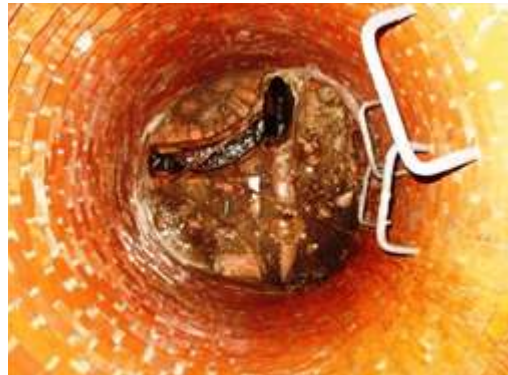
Top View

Corroded steps. Bench debris

Partially enclosed Channel

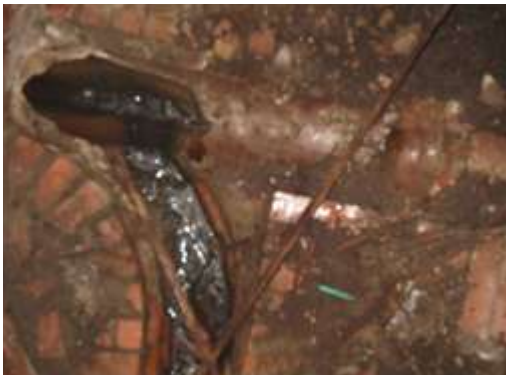
Defect

Corbel and Barrel infiltration.

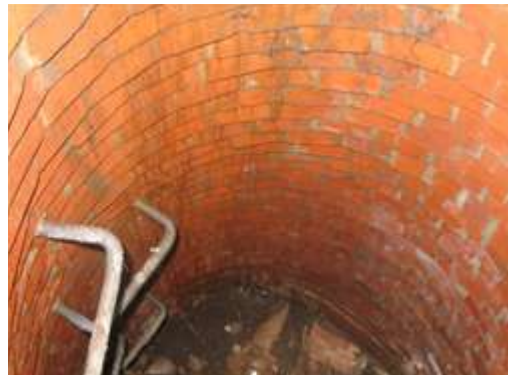
Defect

Barrel infiltration. Corroded steps.

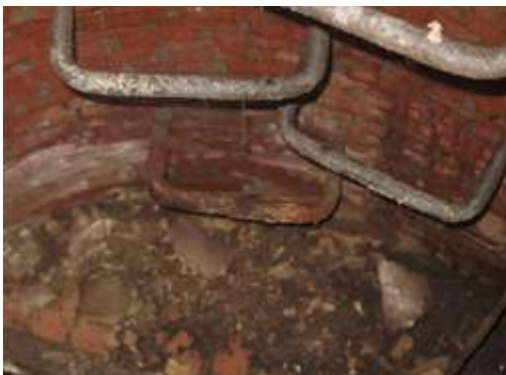
Defect

Frame leaks. Adjustment root intrusion, deterioration, loose brick and infiltration.

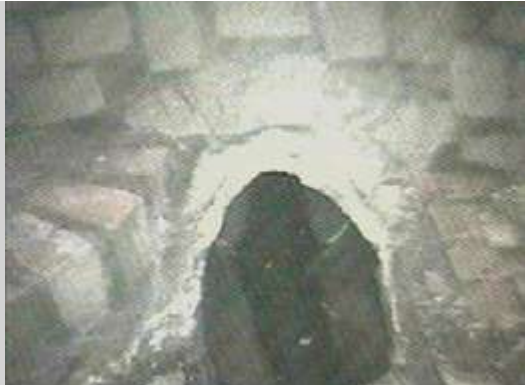
8 in. Circular Gravity Sewer Pipe Out @ 12 O'Clock

Deposits: ☒ None ☐ **Mud** ☐ Sludge ☐ **Debris** ☐ **Grease**

Infiltration: **None**

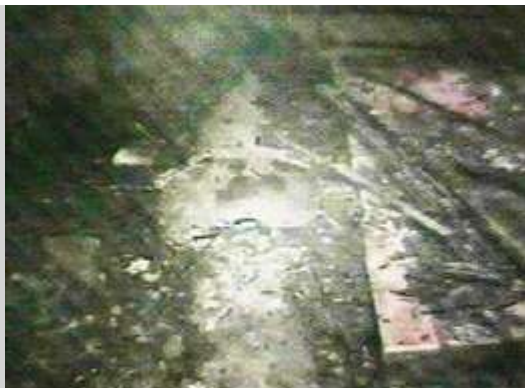
8 in. Circular Gravity Sewer Pipe In @ 6 O'Clock

Infiltration: **Evidence**

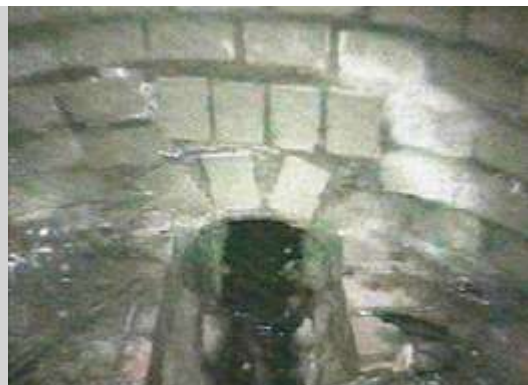
Pipe In @ 9 O'Clock

Deposits: ☐ None ☒ **Mud** ☐ Sludge ☒ **Debris** ☒ **Grease**

Silt Depth: **0.5** (in.) Deposits Extent: **Light**
